BY MARK PARLEE

How to Destroy a Wall In Two Easy Steps

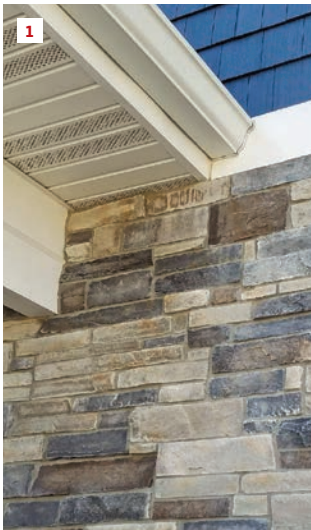
There was little evidence on the outside of the building of a significant problem (1). The exterior cladding consisted of vinyl siding covering the second-story walls, and manufactured stone covering the first-floor walls. Both claddings are incredibly resilient. This particular stone was varicolored with highlights that completely hid any efflorescence (the leaching of minerals onto the surface of masonry) that would have been a sure sign of water problems. But I didn't need to see damage on the outside of the cladding to know that there could be damage behind it. Installing kick-out flashings poorly—or not installing them at all—is a common mistake that allows bulk water into the wall cavity. There was no question in my mind we had to open up the wall to investigate further.

From the outside of the home, there was little damage evident, certainly nothing that indicated that this single section of wall would eventually require \$4,000 to \$6,000 in repairs.

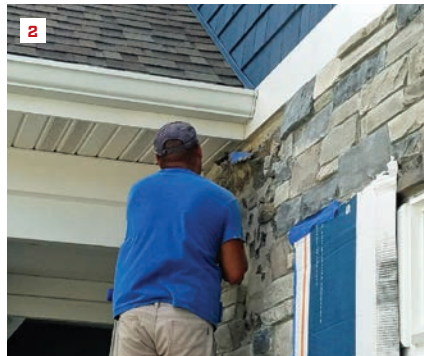
As soon as we started to take apart the wall, we found a good-quality drainage mat over a weather barrier (2). That was a good sign. In theory, this dimpled mat would create a capillary break to interrupt the flow of water through the porous masonry cladding and allow it to flow down through the drainage mat and out the bottom of the wall. Nevertheless, behind these products, the OSB sheathing was rotten (3). This was not too surprising given the lack of a kick out to divert the water. Even with a good drainage plane, the amount of water draining off a roof can overwhelm a drainage system and soak the sheathing.

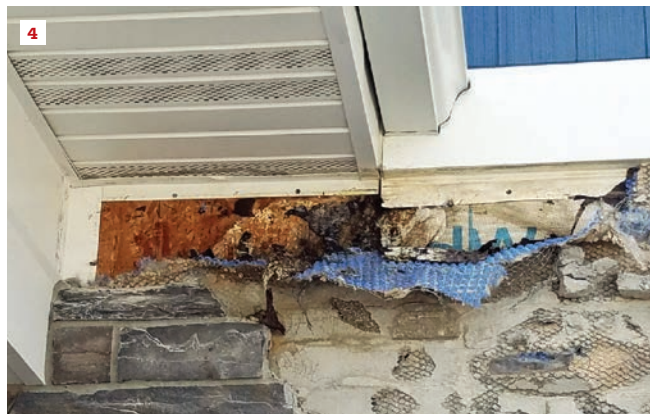
In this case, the bottom channel on the vinyl siding above the roof was acting like a tiny gutter to collect water flowing down the wall and surgically inject it onto the top edge of the frieze board that divided the vinyl and manufactured-stone sections of the wall (4). There was no Z-flashing on this frieze board, either, so chances were high that a significant amount of that water was draining to the back of the frieze and soaking the OSB from above. The drainage mat started below this frieze board, so it wasn't providing any help.

The repair would not be complicated. We needed to tear out and replace all the rotten sheathing and replace all the same elements of the exterior cladding system. This time, however, we would include the two missing elements: a weep screed at the base of the wall, and a kick-out flashing at the base of the roof-wall intersection. In this case, the kick out would need to be installed behind the vinyl J-bead so any water running down that "mini gutter" would be diverted into the roof gutter.

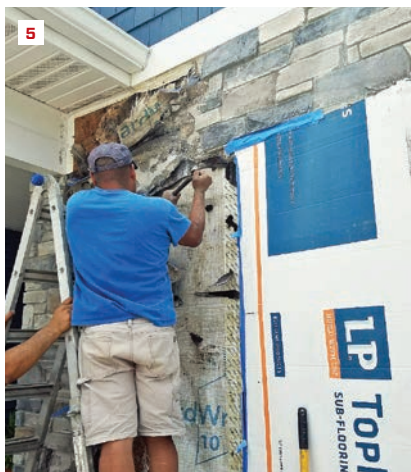
We continued to take the wall apart, stripping the stone back and hoping to come to the end of the rot (5). No such luck. We opened up the entire wall without finding any solid sheathing (6). The worst rot was at the base of the wall (7), illustrating clearly why details matter.

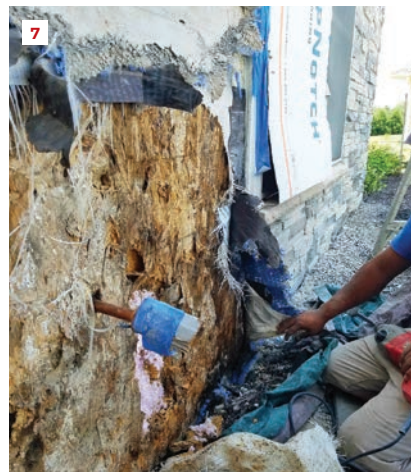
A wonderful drainage mat turns out to be a complete waste of money if you leave out weeps at the base of the wall. There was

nothing like that in this wall. By not creating a way for water to drain out the bottom of the drainage mat, the builder succeeded only in creating a larger reservoir (larger than the manufactured stone itself) to hold all the water that drained down the wall. That water then backed up, easily leaking through the overlaps in the drainage mat and weather barrier and soaking the OSB. Moreover, without a kick-out flashing, he succeeded in creating a tremendously large source of water to feed his reservoir.
