# SIDING

## Common Siding Failures Avoid errors that will cause a fiber-cement job to fail

BY MARK PARLEE

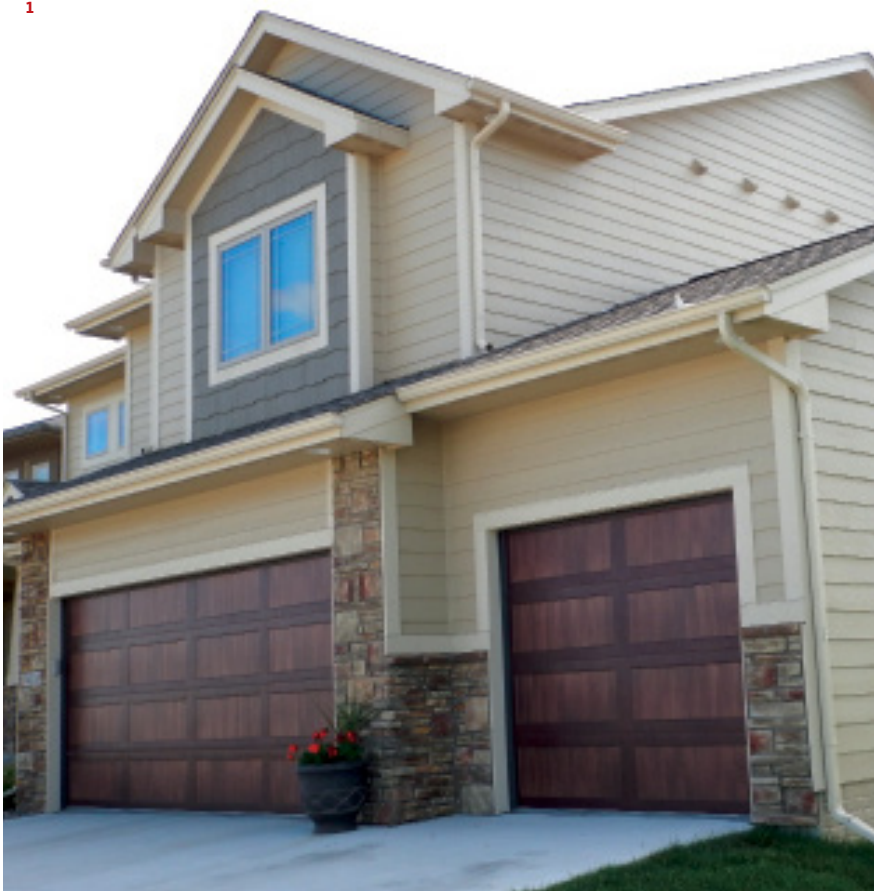
I see a lot of failed siding jobs. The one shown in the photos in this article is typical of the fiber-cement siding jobs I am asked to look at—I could go out right now to hundreds of homes that are in a similar condition. Each one usually looks fine from a distance (1), but when I examine the house up close, I see the same installation errors again and again. For some of the jobs, I am called out to investigate because they have gone to litigation. For others, it's a homeowner complaint. But almost all of them are very expensive to repair.

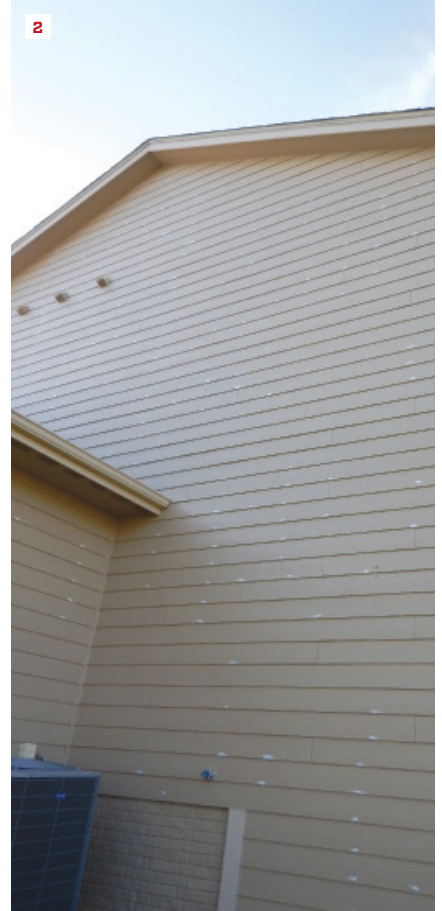
I didn't think the work could be salvaged, and I recommended tearing off all the siding and starting over. However, because the initial complaint was about the vibration of the loose boards, the builder thought he could fix the job by face-nailing the siding (2). But his "fix," along with his attempts to correct the water detail-

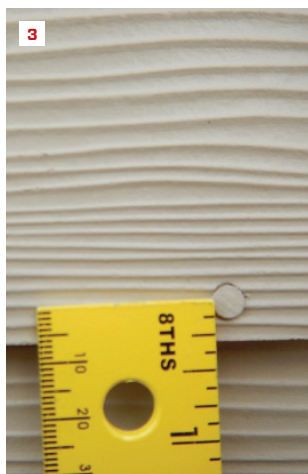
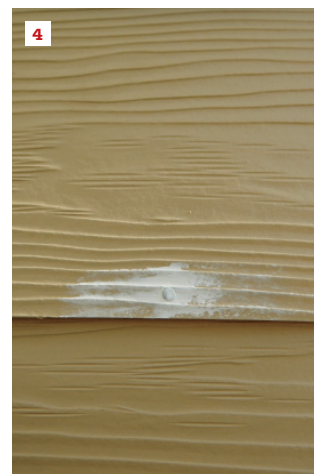
The material used here was MaxTile's MaxiPlank; and according to its ESR, exposed fasteners (face nails) must be placed at least  $\frac{3}{4}$  inch up from the bottom edge. Mostly, this job had been blind-nailed to begin with, but the installers had occasionally placed face nails to hold boards down, and these were only about  $\frac{3}{8}$  inch from the bottom edge (3). At least the nail shown here had been set more or less flush to the surface, whereas all the face nails the builder had retrofit not only were too close to the bottom edge, but also had been over-driven—and the divots had been filled with spackle (4).

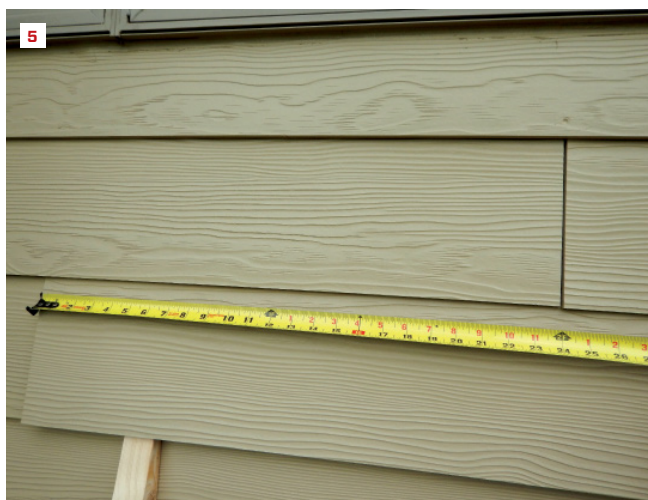
On this job, however, the butt joints were not located over the studs (5). The house was framed on 16-inch centers, while many of the butt joints were offset by 24 inches.

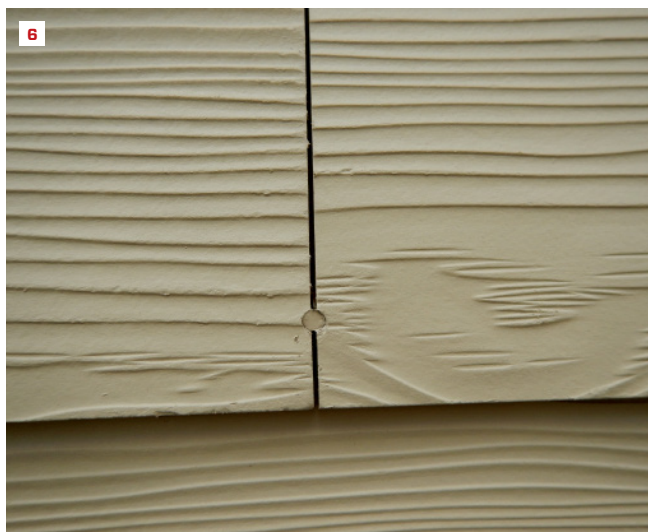
At the butt joints, the builder had initially made an attempt to hold the ends down with a single nail strategically placed to hold both ends (6)—an incorrect detail that I see all the time. I have also seen installers try to pin the ends down (7). Neither solution will provide enough holding power to secure the siding.

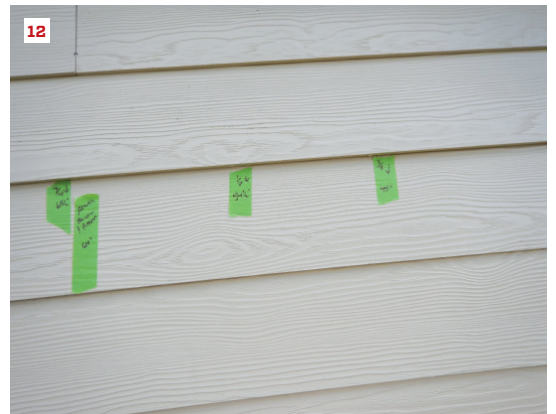
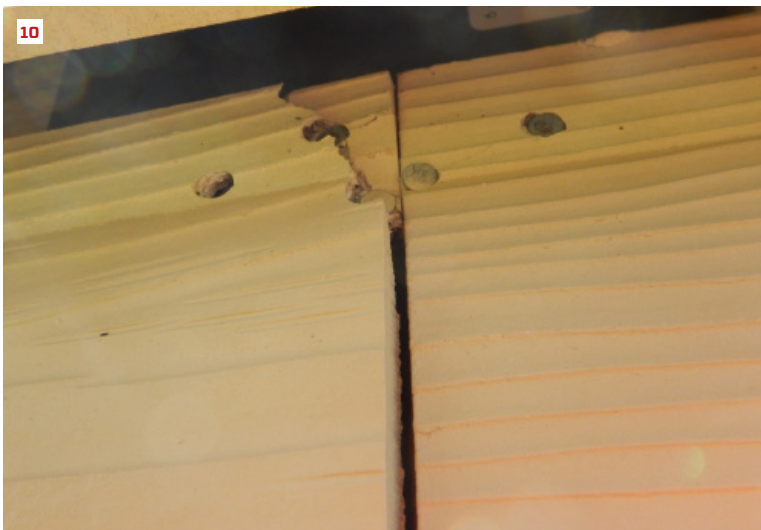
The reason for requiring a minimum distance from board edges and ends is clear: When a fastener is placed too close to an edge, the material tends to break around the fastener (10, 11) when boards expand and contract with changes in temperature, or when wind forces push and pull on the material. The vibration caused by loose boards fluttering in the wind no doubt accelerated this failure and is why so many of the fasteners on this job had completely failed.

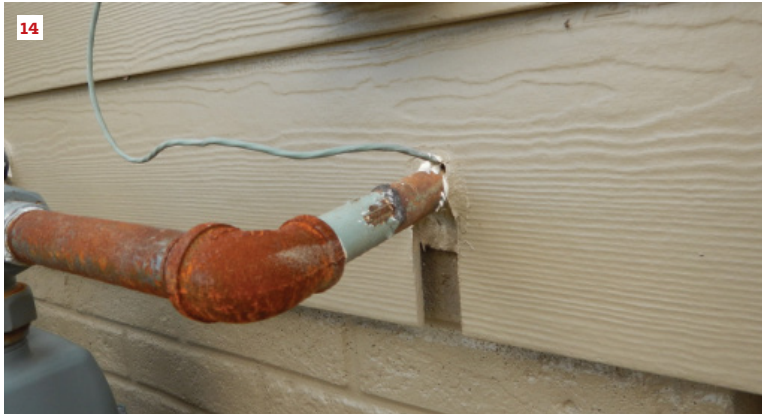
There were a number of egregious water-detailing problems too. One of the worst was a siding break made directly above a dryer vent (13). Water leaking through this joint hit the vent pipe and followed it to the interior, where, not surprisingly, we found water marks. At all the other penetrations—at the gas line near the meter (14) and the hose bib (15)—the siding had simply been slotted around the pipe or vent, which not only looks bad, but also leaves the wall open to serious water and air leaks.
