On the Job

Mixing Cladding and Stick-On Stone

by Mark Parlee

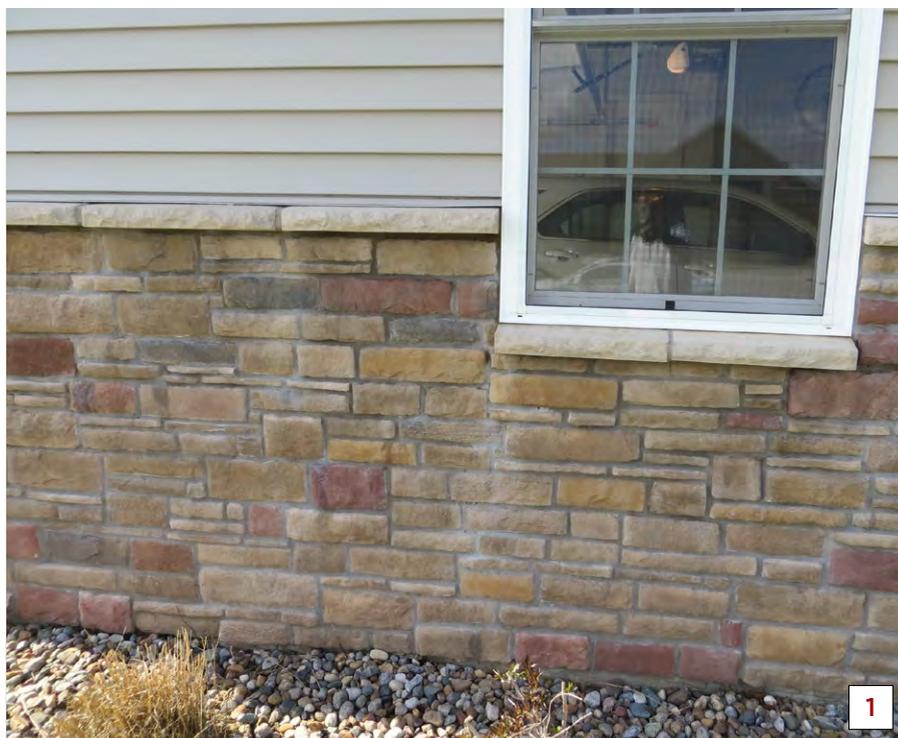
I was recently called in to look at a house sided with vinyl siding and ACMV. Water staining on the interior drywall and leakage below a window in the garage prompted the call, but inspection also revealed efflorescence on the stone (1), damage to the OSB near the foundation sills in other parts of the house (2), and corrosion, even rot, around fasteners through the sheathing (3).

The efflorescence reveals where water is concentrating as it drains from the upper walls and windows. The ACMV is absorbing this water, and as it evaporates from the stone, it is bringing calcium hydroxide (from the lime in Portland cement) to the surface, where it reacts with the carbon dioxide in air to form a white powder. This is normal for any concrete product. What makes it noticeable is that the wall is becoming disproportionately wet

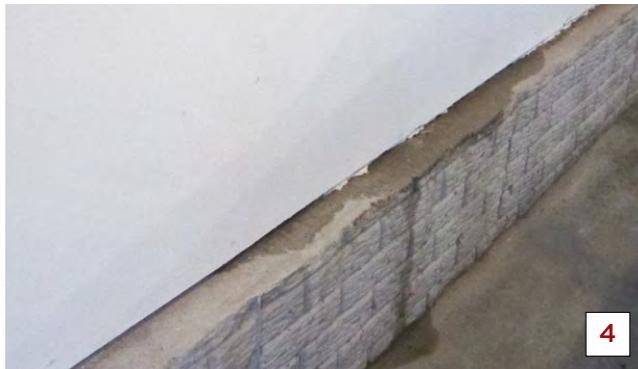
After hosing down the upper wall to confirm the leakage pathway (4), we tore off the drywall below the window to reveal a wet wall cavity with mold-infested OSB (5).

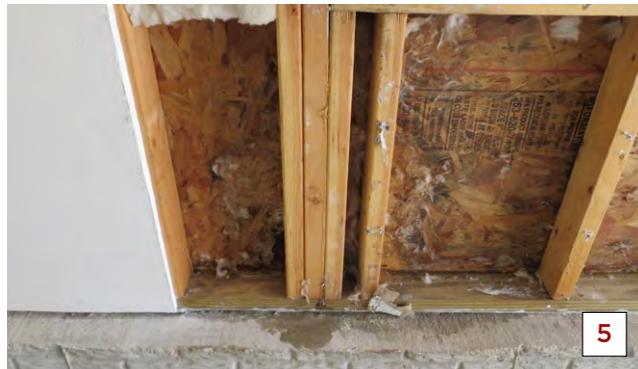
The problem was a poor flashing detail at the edge of the window and the lack of an effective drainage plane behind the ACMV. The builder had applied a single layer of housewrap to the walls, before slathering them up with mortar and applying the ACMV. Any water draining from the upper walls hit an ACMV dam, and traveled in three ways:

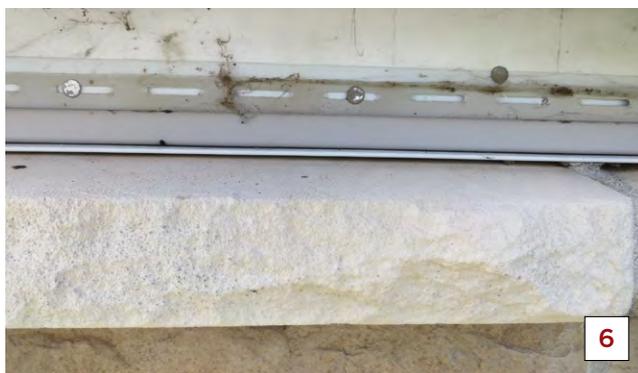
- Some of the water flowed down the crack between the housewrap and the ACMV. There was no flashing here, just the vinyl starter strip (6).
- Some water flowed down the exterior, soaked through the ACMV, passed through the housewrap by capillary action, and soaked the OSB sheathing, where we measured 55% moisture content (7).

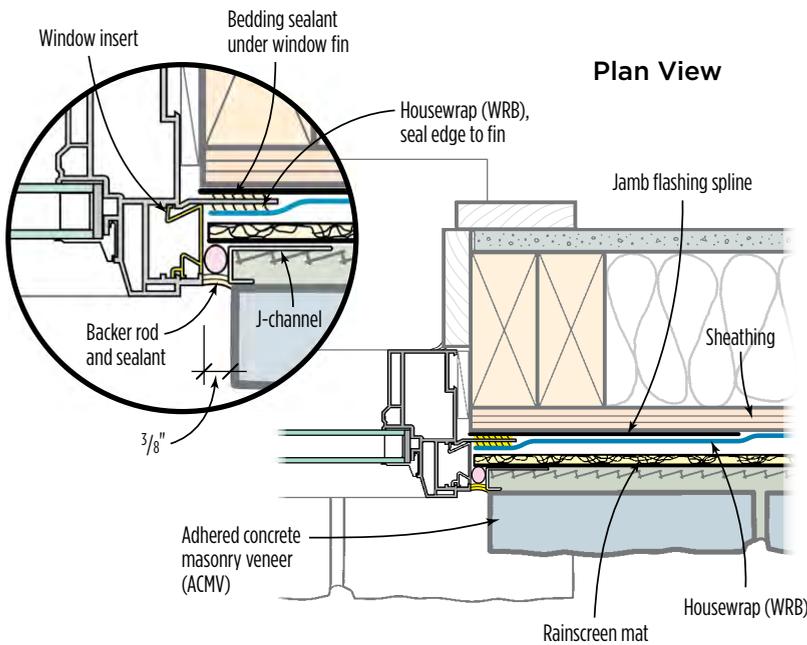
8 Window Jamb

• And some of the water flowed around the window flange and down the wall studs inside the garage. The window had a built-in J-channel to receive vinyl siding. This worked well for the upper part of the window that butted against vinyl, but on the lower part of the window that abuts the ACMV, there was a big open channel that allowed water to drain right into the wall.

What's required here is an insert (available from window manufacturers that make this type of vinyl window) to fill the J-channel, and then backer rod and sealant installed between the window insert and the ACMV (8). Getting a good seal using backer rod requires a skilled installer. A more foolproof way to create a durable seal between the ACMV and the window flange is to install a vinyl casing bead, such as E-Z Bead (amico-lath.com/e-z-bead.htm), to create the proper sealant channel.
