## A Rot-Resistant Chimney Chase

by Mark Parlee

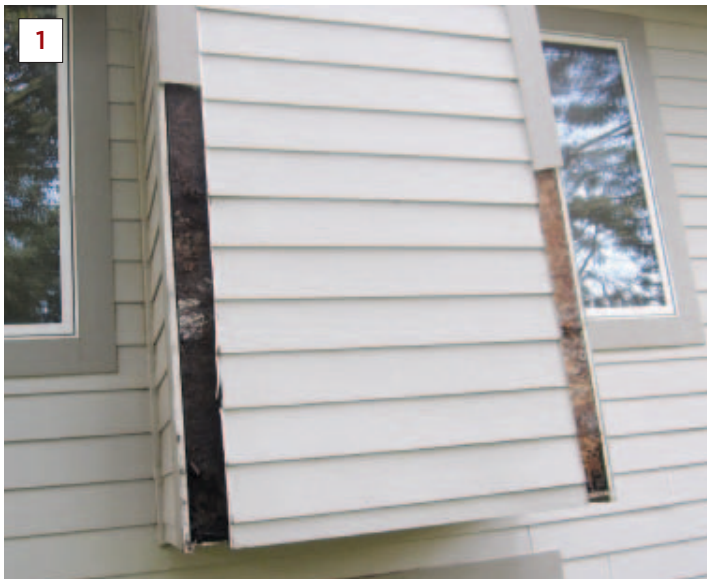
Framed chimney chases seem to be especially vulnerable, and I've repaired a lot of them over the years. For example, the house shown here was built just a few years before my crew and I began working on it, but already the paint was peeling from the fiber-cement clapboards and the corner boards had begun to rot (1). When we dug a little deeper, we discovered deteriorated sheathing and rotted framing, too (2, 3).

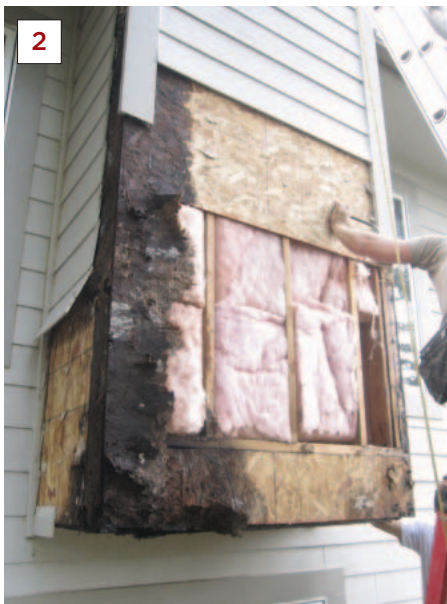
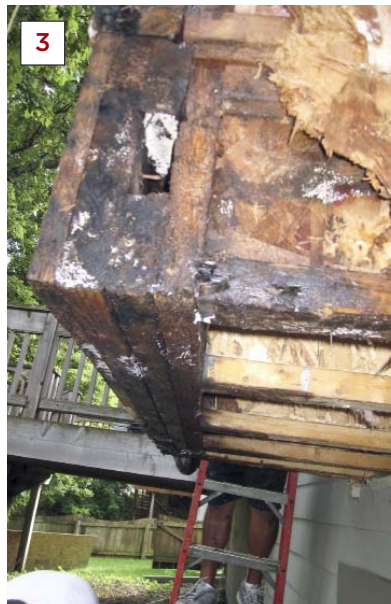
We found that most of the damage had been caused by water from the roof running behind the siding and down the sheathing — the result of some missing step flashings (4). Adding to the problem, the chase's OSB sheathing hadn't been covered with a water-resistive barrier. In an attempt to save a few hundred dollars, some builders omit housewrap over garages, chases, and gables in the mistaken belief that it's not required by code over unheated wall assemblies. In this case, a few extra flashings and some housewrap could have prevented thousands of dollars in damage.
