BY MARK PARLEE

How to Destroy a Wall In Two Easy Steps

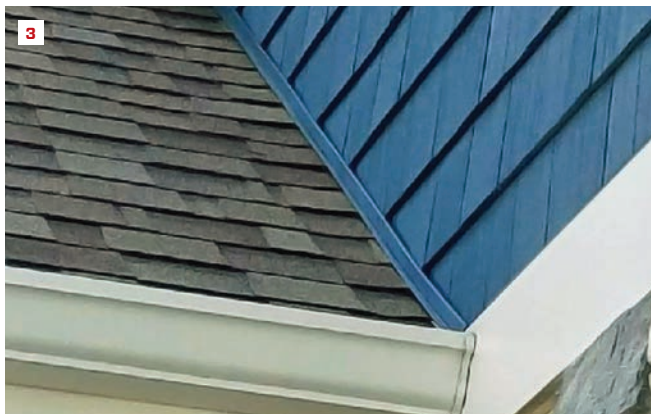
From the outside of the home, there was little damage evident, certainly nothing that indicated that this single section of wall would eventually require \$4,000 to \$6,000 in repairs.
